National Transportation Safety Board Aviation Accident Preliminary Report

Location:	Daytona Beach, FL	Accident Number:	ERA18FA120
Date & Time:	04/04/2018, 0953 EDT	Registration:	N106ER
Aircraft:	PIPER PA28R	Injuries:	2 Fatal
Flight Conducted Under:	Part 91: General Aviation - Instructional

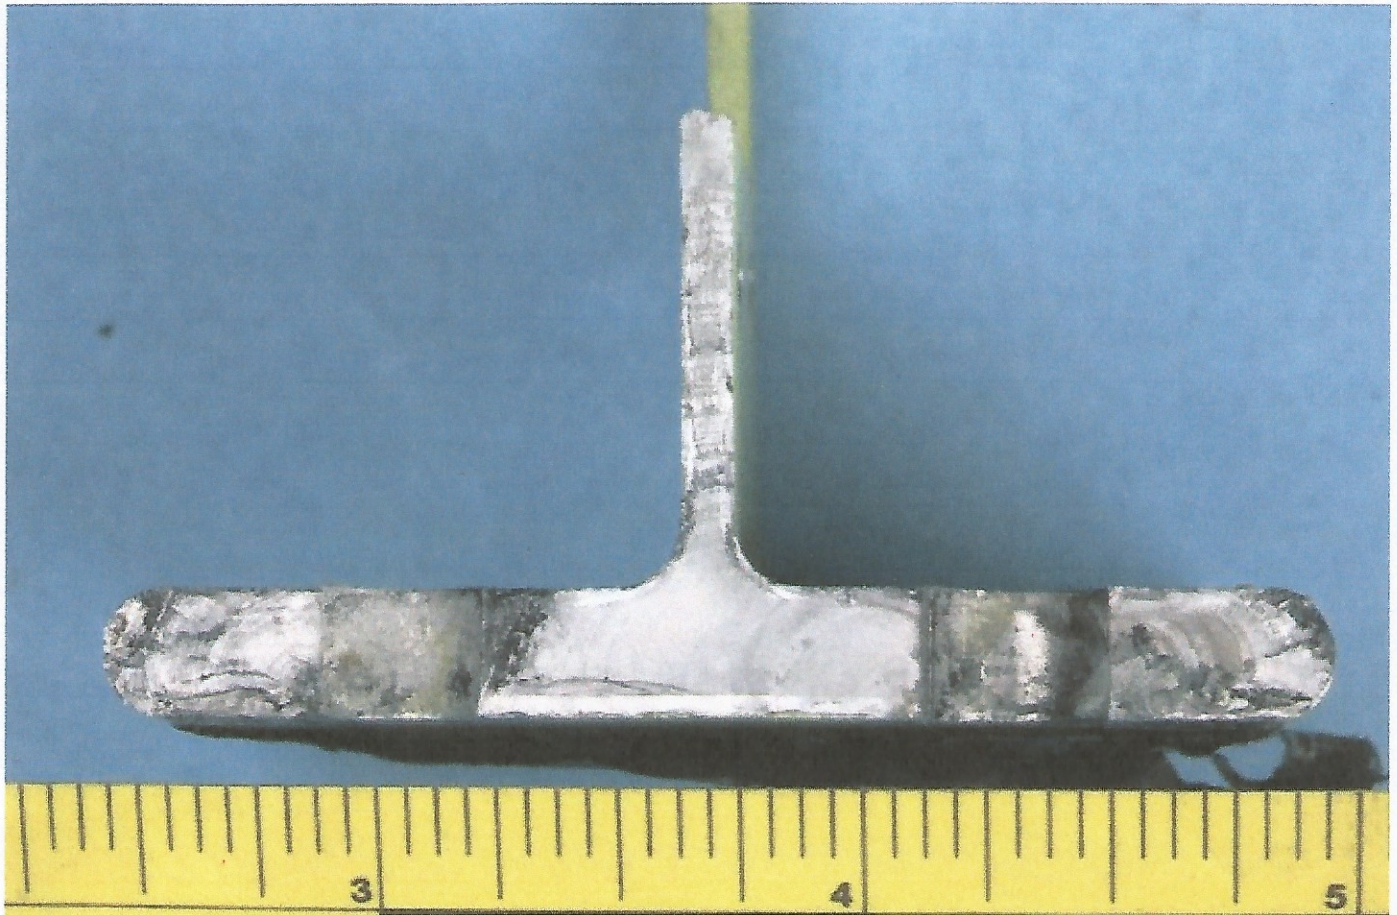
The fractured left wing main spar portions, along with the box assembly and attached inboard end of the right wing main spar, were forwarded to the NTSB Materials Laboratory for detailed examination. Preliminary examination of the left wing main spar revealed that more than 80% of the lower spar cap and portions of the forward and aft spar web doublers exhibited fracture features consistent with metal fatigue (see figure 1).

Figure 1 - Left wing main spar lower cap fracture surface.

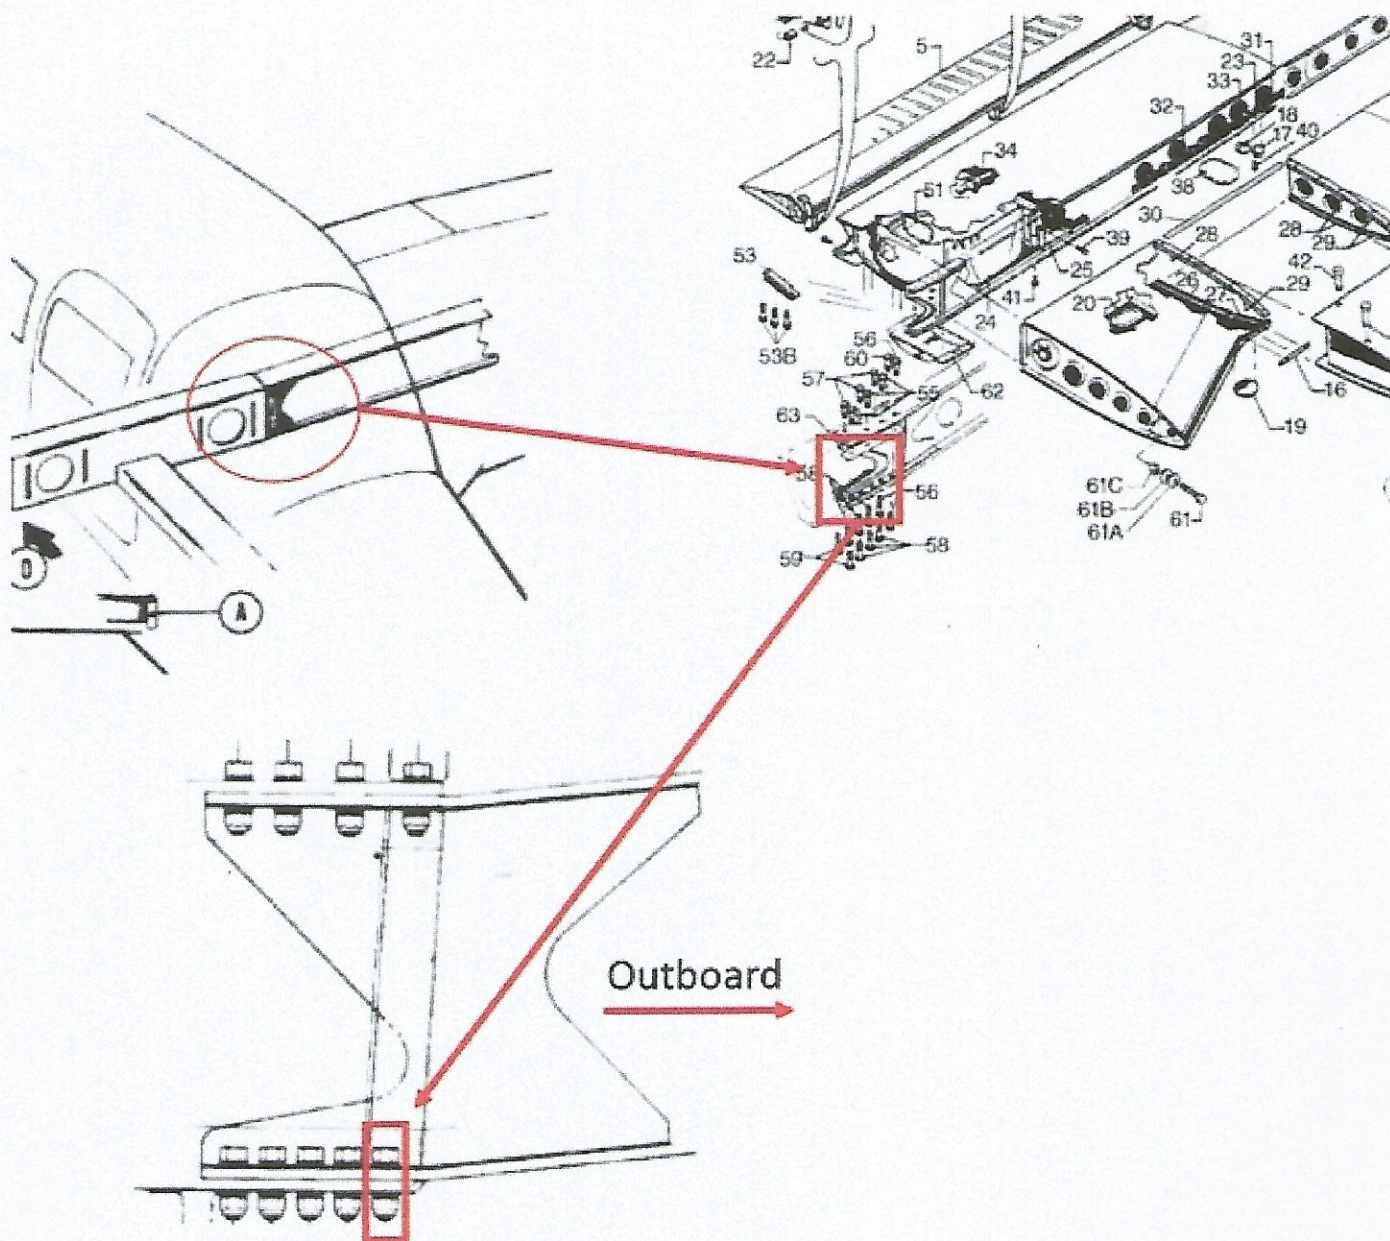
The remainder of the lower spar cap, spar web doublers, and upper spar cap displayed fracture features consistent with overstress fracture. The fatigue features originated at or near the outboard forward wing spar attachment bolt hole (see figure 2). None of the surfaces exhibited visible evidence of corrosion or other preexisting damage. The right wing also exhibited fatigue cracks in the lower spar cap at the same hole location extending up to 0.047-inch deep.

Figure 2 – Exploded view of left wing spar assembly and attachment bolts.
