Piper Aircraft, Inc.
2926 Piper Drive
Vero Beach, FL, U.S.A. 32960

SERVICE NO. 1345A BULLETIN

Date: September 17, 2021

MAIN WING SPAR INSPECTION

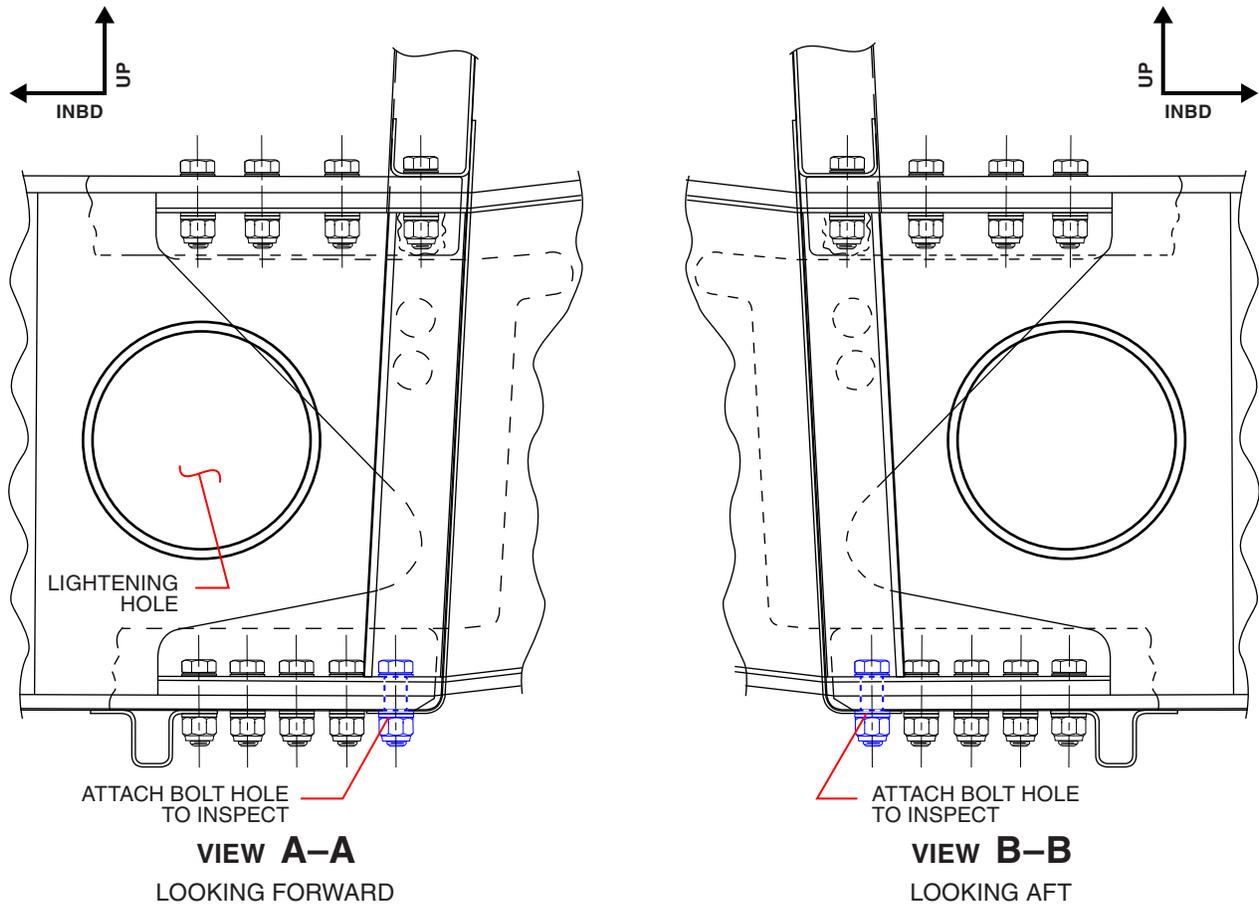
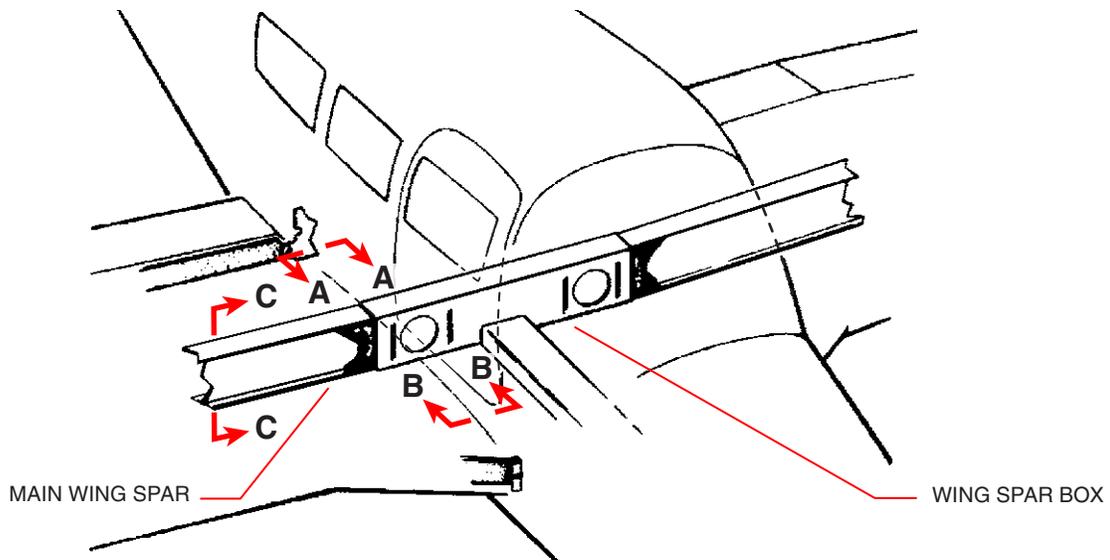
Figure 1, Sheet 1 of 2
Typical Main Wing Spar Attach Bolts and Spar Cross Section (Right Wing Shown)

3. Inspect the inner surface of each bolt hole in the lower wing spar cap. Figure 1 provides cross sections of the main wing spar, and identifies the bolt hole inspection areas.

WARNING: Do not drive bolts into or out of the main spar attaching bolt holes (see Views A-A and B-B). Be careful to avoid damaging the bolt holes while removing and replacing the bolts. Refer to "Care for Bolts and Bolt Holes" in this service bulletin.

NOTE: When radius washers are properly installed, the radius feature of the washer will be oriented to match the radius of the adjacent structure, as shown in Figure 1, Detail D.

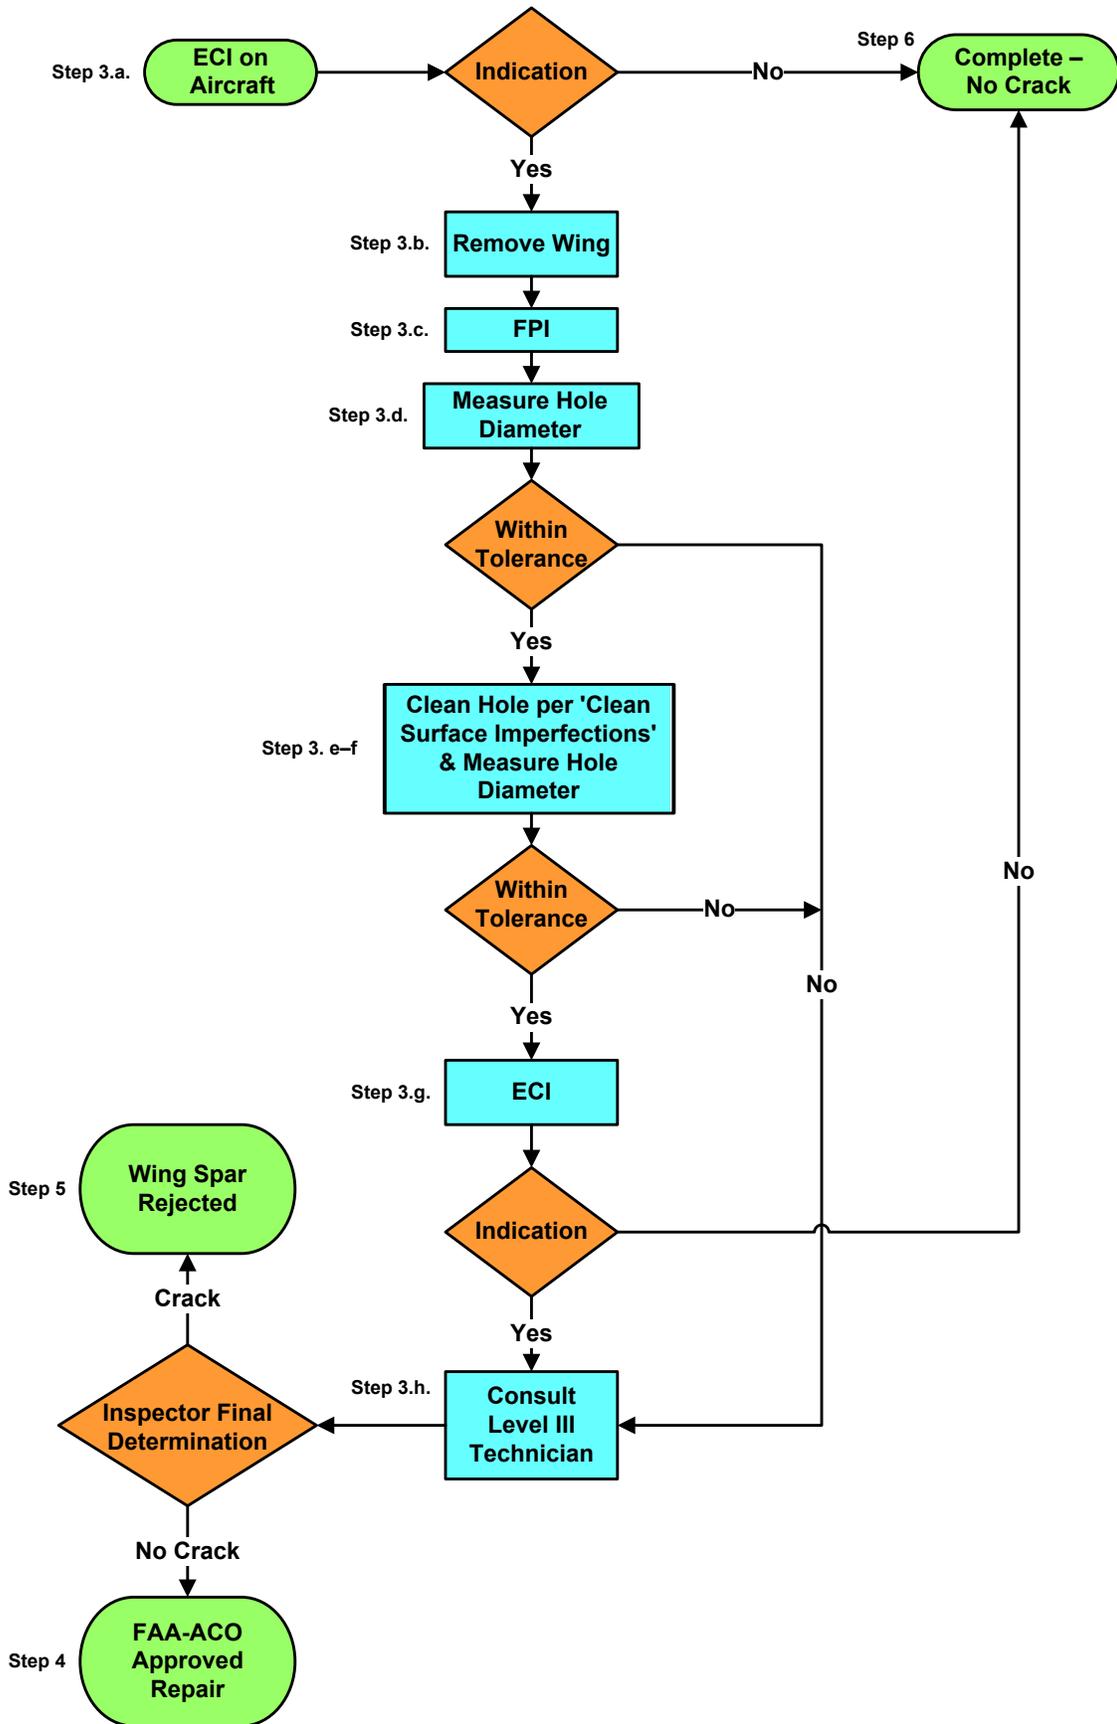
Figure 2
Inspection Process Flowchart

- The inspection steps in these instructions are visualized in Figure 2, a process flowchart.
 - It is recommended that technicians prepare and/or enter their responses on the feedback form throughout the inspection process. (For legibility, fill out the form digitally, printing it only for signature purposes.)
