Beechcraft

SERVICE BULLETIN

MTB-57-01

WINGS - INSPECT THE AFT UPPER AND LOWER WING BOLTS FOR CORRECT WASHER AND REPLACE IF NEEDED

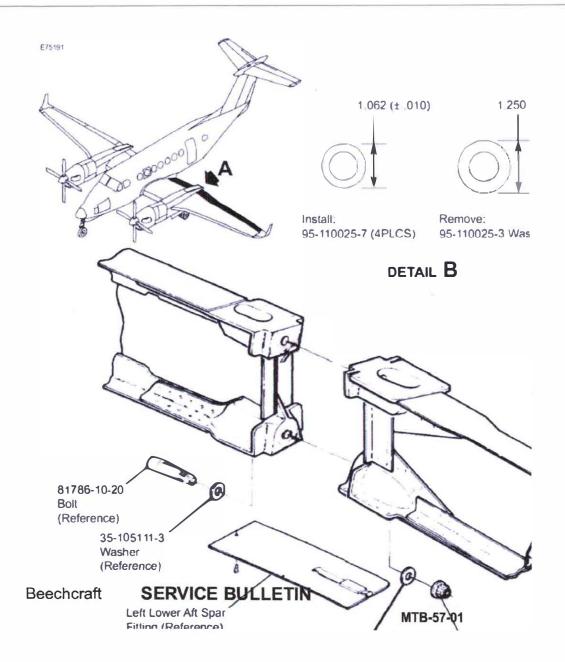
- (Refer to Figure 1, Sheet 1.) Examine the aft upper and lower wing bolls for the correct wing bolt washer as follows.
 - CAUTION: These inspections should be completed one attach-point at a time with the bolt installed and correctly torqued before moving to the next location. During removal the aft upper and lower wing bolts, make sure the wing is supported in a manner which will prevent the possibility of movement of the upper-attach fittings.

- Remove the left upper and lower aft spar bolts.
 - B. Determine if a 95-110025-7 Washer is installed at the shown position on 81786-10-20 bolt.
 - (1) If a 95-110025-7 Washer is installed, no further action is required. Go to Step 3.

- (2) If a 95-110025-7 Washer is not installed, go to Step 2.C.
 - C. Remove the 81786-10-20 Bolt and remove the 95-110025-3 Washer from the bolt.

- E. Install a new 95-110025-7 Washer on the 81786-10-20 Bolt. (Refer to King Air Structural Inspection and Repair Manual, Chapter 57.)
- Install the left upper and lower aft spar bolts.
