SAIB: 2022-20
Date: October 19, 2022

SUBJ: Wing Spar

This Special Airworthiness Information Bulletin (SAIB) alerts all owners, operators, maintenance technicians, and inspectors of **Piper Aircraft, Inc. (Piper) PA-28 and PA-32** airplanes of information gathered as result of a fatal accident of a Piper Model PA-28R-201 airplane in 2018 and the inspection findings that followed. The accident, determined to be caused by fatigue cracks in the lower spar cap, resulted in the Federal Aviation Administration (FAA) issuing Airworthiness Directive (AD) 2020-26-16, which requires several actions including a one-time inspection of certain lower spar cap bolt holes. AD 2020-26-16 was issued as an interim action and requires reporting certain inspection information to the FAA to help determine the number of cracks present in the fleet. The inspection reports received by the FAA thus far indicate the presence of numerous cracks and hole-quality issues in a significant number of airplanes.

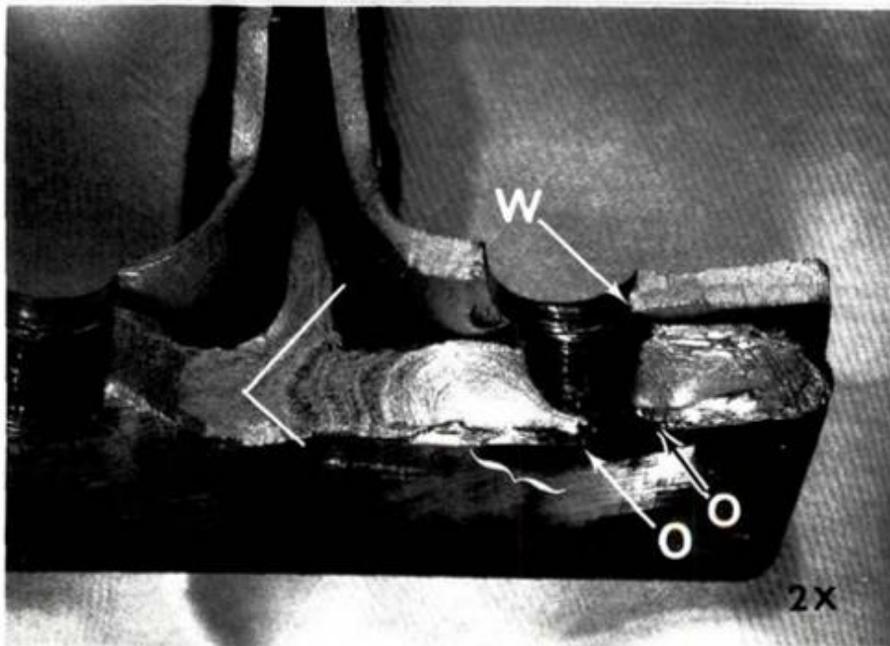
The first related accident occurred in 1987 in Marlin, TX. The accident airplane was a Piper Model PA-28-181 airplane with 7,490 hours TIS. Nearly all of this airplane's flight time was known to be spent in a "Pipeline Patrol" mission. This type of mission is characterized by very low altitude and terrain following flight profiles. These flying characteristics degrade an aircraft's structure faster than most other missions. See Figure 10 for a view of the accident airplane's failed spar, where "O" indicates fatigue crack origins and "W" indicates a web fatigue crack.

**Figure 10. 1987 Accident, Failed Wing Spar
PA-28-181, 7,490 hours TIS; O indicates crack origin**

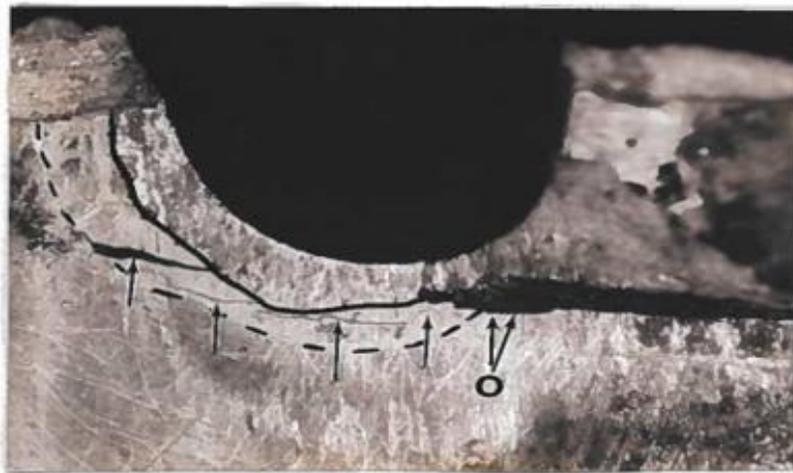
The second of these accidents occurred in 1993 in Provincetown, MA. The accident airplane was a Piper Model PA-28-181 airplane with 11,683 hours TIS. This accident was attributed to weather with signs of structural overloading, but a fatigue crack was also found in the failed spar. The crack is beyond the critical crack size later calculated for that spar. While the NTSB did not identify the fatigue crack as the probable cause of the accident, its presence may have contributed to the effect of the structural overload. At the time of the accident, the airplane was being flown for personal use; however, the airplane was operated by a company providing a mix of training and charter flights. The training mission type of flying is characterized by low altitudes and many takeoff and landing cycles. While less severe than a “Pipeline Patrol” mission, the training mission would contribute more towards fatigue than personal use. See Figure 11 for a view of the accident airplane’s failed spar near a bolt hole, where “O” indicates fatigue crack origins. The origin in this case was adjacent to the hole, not in the hole, as in the 2018 accident.

**Figure 11. 1993 Accident, Failed Wing Spar
PA-28-181, 11,683 hours TIS; O indicates crack origin adjacent to the bolt hole**
