Aircraft and Owner/Operator Information

Aircraft Make	Model	Registration	N/CASB
Boeing	737 MAX 8	FAA N18112	FAA
Operator	Delta Air Lines	Operating Certificate(s)	FAA
Manufacturer	Boeing	Flight School (FAA)	FAA

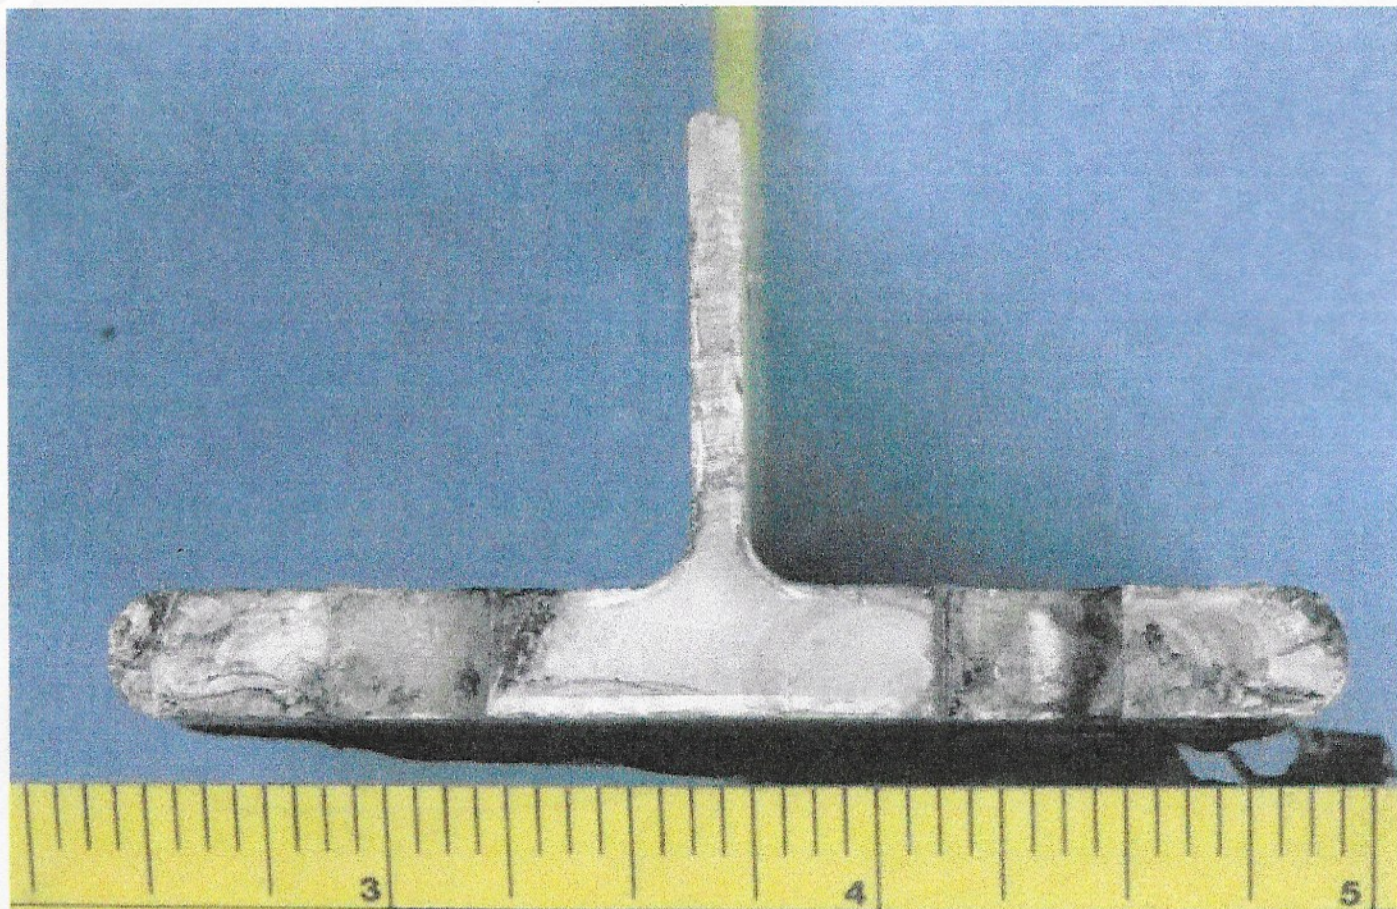
Figure 1 - Left wing main spar lower cap fracture surface.

The remainder of the lower spar cap, spar web doublers, and upper spar cap displayed fracture features consistent with overstress fracture. The fatigue features originated at or near the outboard forward wing spar attachment bolt hole (see figure 2). None of the surfaces exhibited visible evidence of corrosion or other preexisting damage. The right wing also exhibited fatigue cracks in the lower spar cap at the same hole location extending up to 0.047-inch deep.
